A CULTURAL HERITAGE IN ALANYA: ALARA (DOWN) BATH

In this paper, a general evaluation will be done about architectural features of the building which was named "Down Bath" and had been unearthed by excavation during Alara Archeological Excavations.

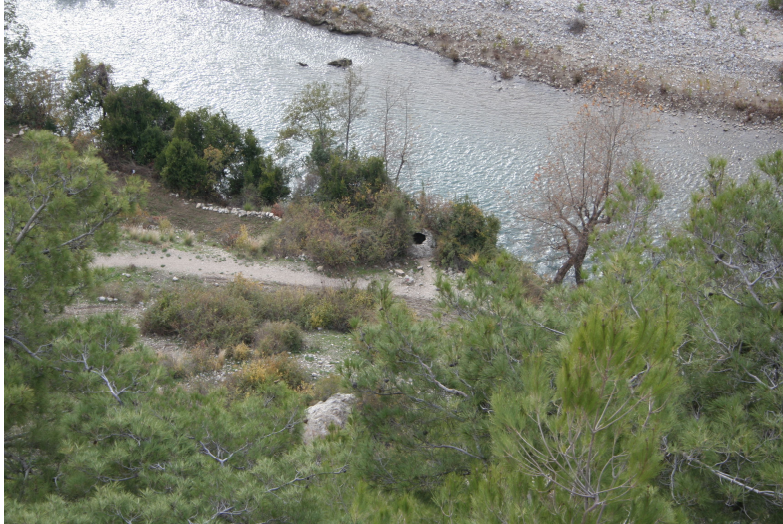
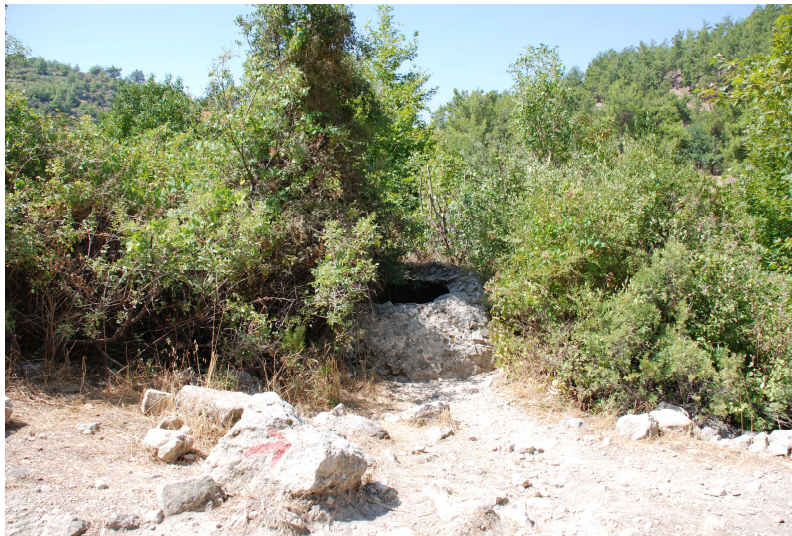
Fig. 1

The bath was the most important of the structures which were partly found out as a result of the first excavation in 2007. The Down Bath was located on the bank of the Alara Streamlet and outside the fortification wall of the castle which was stretching like a set and got lost under the plants by remaining under the soil almost completely. The structure got damaged at the times the streamlet overflowed due to its location and a significant part of it has fallen down today as well. Before the excavation works were started only a specific part of the dome of the structure was observed (Fig. 1-2).

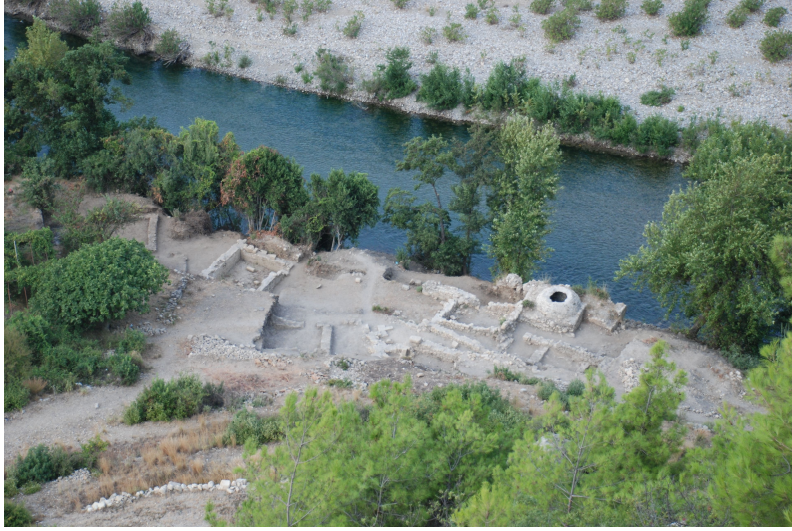
Fig. 3

In the first excavation season, the works were concentrated on and around the bath and the features of architectural plan related to the structure were tried to be found out. The works were started with the follow-up of the fortification wall which was stretching along the Alara Streamlet. A water tank was discovered in ruins in the north-east of the structure. Inside the place covered with dome, in the furnace and in the other places, 2 meter top-soil that was applying pressure to the structure was removed. The top-soil that was removed was analyzed in detail but no foundling was found. A low arched door was unearthed by removing the top-soil in the west of this place as well. The height of the door was 1.5 m. and the width was about 70 cm. Moreover, another structure was discovered in the south east corner of it next to the bath. Finding small metal foundlings and forger tools inside indicates that the place used to be a smithery (Eravşar, 2010, 8) (Fig. 3).

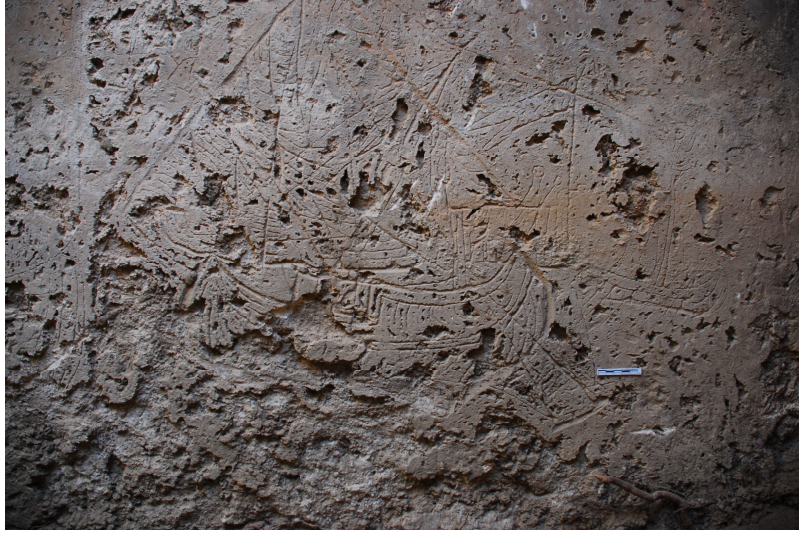
Fig. 6

As a result of the studies on and around the bath, some graffiti were found on the walls of some places (especially the north) inside the bath (Fig. 6). During the works in 2008, the paper copies of some graffiti were taken with a firing up but when no success was achieved since the plaster was damaged too much, they were documented by means of photogrammetric methods (Draw. 2). Most of the graffiti which were damaged constituted different compositions along the north wall (Eravşar, 2012, 8). Intertwined sails,

human figures on the deck of the ship and different sizes of boats were on the forefront here. On the other hand, the most significant of the compositions was the description of a ship and a man leaving this ship in a boat. This composition differs from the other graffiti in size. Among the likes of graffiti examples that were seen at the towers of Alanya Castle, cisterns and at small mosques, this graffiti differs in subject.

Taking into account the development of the region in the 13th century, the bath was not designed in large scale but the graffiti in the temperature place came to the forefront despite its modest material features. It is possible to see the intertwined ship with flags especially on the north wall, the boat with people on them and the likes of human figures in recent era examples in and around Alanya (Bilici, 2008, 25-65).
